How should I treat a percutaneous posteromedial mitral periprosthetic paravalvular leak closure in a bioprosthesis with no radiopaque ring?

Paul T.L. Chiam^{1,2*}, MRCP; Ping-Ping Goh¹, MRCP; Yean-Teng Lim^{1,2}, MRCP

CASE SUMMARY

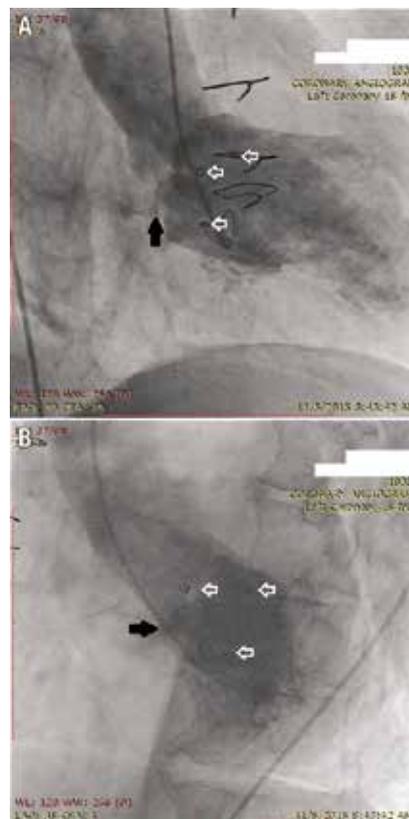
Figure 2. Pre-procedure LV angiography. A) LV angiography image (RAO cranial view) showing the location of the MR jet (black arrow) and the markers of the stent posts (white arrows). Note the lack of a radiopaque ring. B) LV angiography (LAO view) showing the location of the MR jet (black arrows) and the markers of the stent posts (white arrows). Note the lack of a radiopaque ring.

A 66-year-old male presented with worsening dyspnoea (NYHA Class III-IV), due to cardiac failure for several months. He had had a mitral valve replacement with a 27 mm Mosaic[®] bioprosthesis (Medtronic, Minneapolis, MN, USA) nine years before. Transthoracic echocardiography (TTE) and transoesophageal echocardiography (TEE) revealed a left ventricular ejection fraction (LVEF) of 45% and severe mitral regurgitation (MR) due to a paravalvular leak (PVL). The defect was located posteromedially (4 o'clock position on the surgical view) and measured 3 mm at its width (**Figure 1A, Figure 1B**). The effective regurgitant orifice area was calculated to be 0.4 cm² and the regurgitation volume was 64 ml. The bioprosthetic valve leaflets were well visualised to be functioning normally and not thickened, with satisfactory haemodynamics (mean pressure gradient 7 mmHg). Coronary angiography showed no significant coronary artery disease. A left ventriculogram showed an MR jet located posteriorly and medially (**Figure 2A, Figure 2B**).

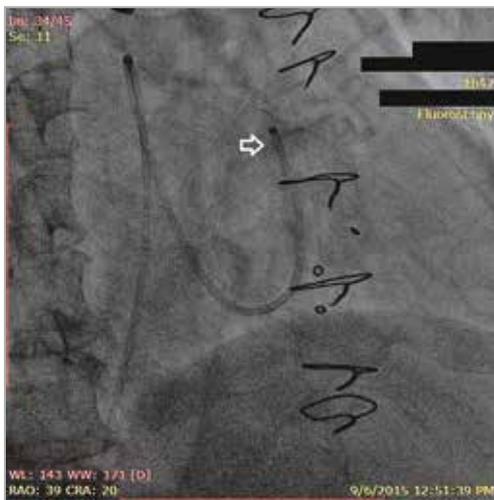
Figure 5. Fluoroscopy image showing the Shuttle sheath crossing the PVL antegradely into the ascending aorta (arrow).

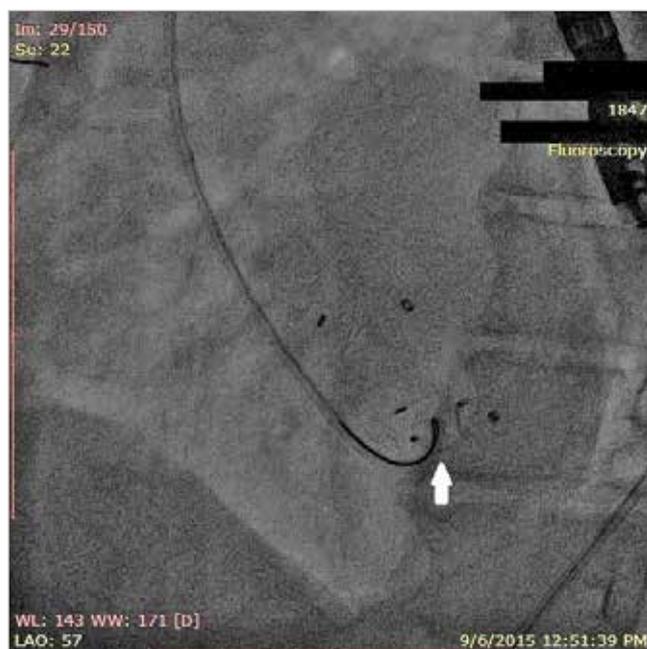
Figure 10. Fluoroscopy image showing the dislodged AVP-III in the LV and the GooseNeck snare within the internal mammary (IM) guide catheter (arrow).

We immediately proceeded to attempt to snare the dislodged AVP-III. The sheath size in the left femoral artery was increased from 6 Fr to 8 Fr. As the device was not in a stable position, but was alternately embolising back and forth from under the mitral valve to the LV apex to the left ventricular outflow tract, it was finally snared after prolonged attempts with a 7 Fr internal mammary shape guide catheter and a 10 mm GooseNeck snare (**Figure 10**). The device, snare and guide catheter were successfully removed as a unit through the femoral sheath.
