Percutaneous atrial septal defect closure in a case of Poland syndrome with dextrocardia

Akshay Bafna*, DM; Varun Deokate, DM

Rajarshi Chhatrapati Shahu Maharaj Government Medical College, Kolhapur, Maharashtra, India

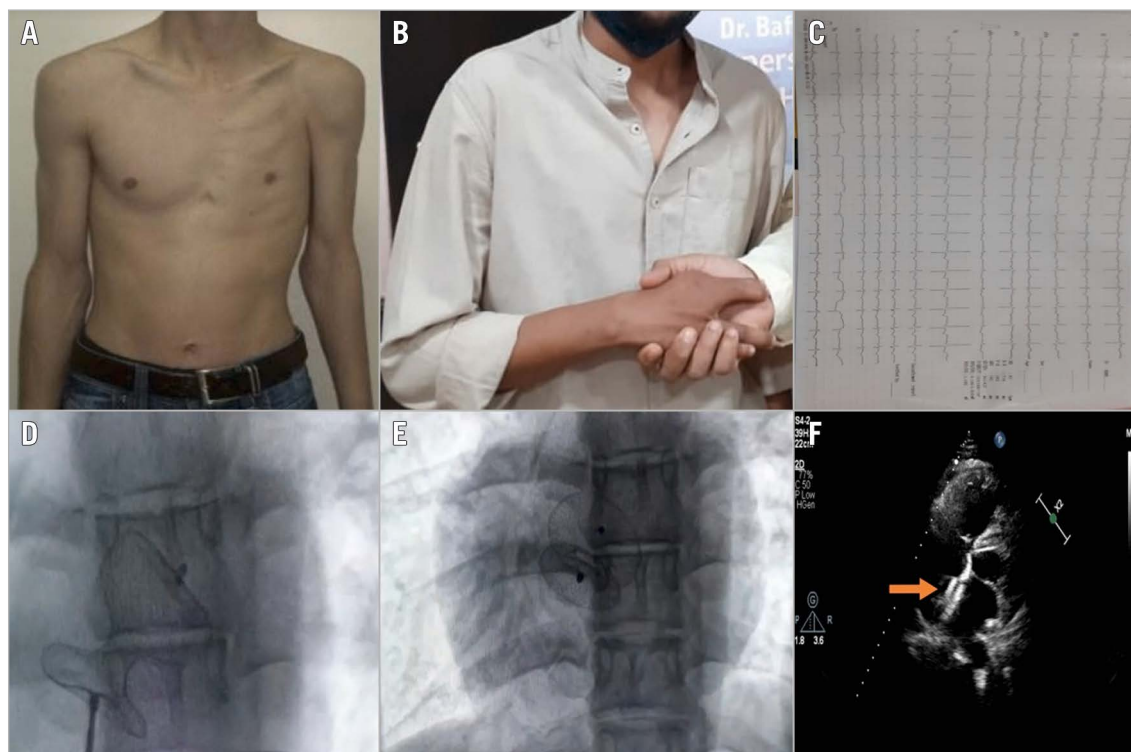
Figure 1. Percutaneous atrial septal defect closure in a case of Poland syndrome with dextrocardia. A) Physical examination showing depression of the left anterior chest wall. B) Patient's right hand with bilateral syndactyly of second and third fingers. C) Electrocardiogram showing within normal limit. D) Fluoroscopic image showing loaded Amplatzer Occluder. E) Fluoroscopic image showing appropriate positioning of Amplatzer ASD closure device. F) Transthoracic echocardiography confirmed the appropriate positioning of Amplatzer ASD closure device.

A 16-year-old male presented complaining that for six months he had suffered dyspnoea on exertion and easy fatigability. A physical examination showed depression of the left anterior chest wall (**Figure 1A**), cardiac apex at the fifth right intercostal space below the nipple, and bilateral syndactyly of second and third fingers of his right hand (**Figure 1B**). A radiological examination revealed the absence of the major pectoralis muscle on the left side and mirror-image dextrocardia. The second heart sound was noted fixed and widely split. His vital signs were within normal range and the electrocardiogram (**Figure 1C**) examination was unremarkable. He was haemodynamically stable with normal peripheral pulse and 98% SpO₂. An echocardiogram revealed a 22 mm secundum atrial septal defect (ASD) leading to significant left-to-right shunting. The diagnosis was a rare case of Poland syndrome and dextrocardia with ASD.

Percutaneous closure of ASD was performed the next day through the right femoral vein under local anaesthesia. The right femoral vein was accessed and a 6 Fr Judkins right catheter (JR) was advanced through the inferior vena cava, followed by the right and left atrium over a 0.035" double length J-tip wire (Translumina Therapeutics). The 6 Fr JR was exchanged for a 0.035" DL J-Tip Amplatz Super Stiff wire (Boston Scientific). The wire tip was positioned in the left superior pulmonary vein. A 12 Fr Amplatzer ASD Occluder (Abbott) delivery sheath was used with a (145°) distal curve. A 28 mm Amplatzer Occluder was loaded and advanced through the sheath (**Figure 1D**). The occluder disc was deployed in the left atrium, and the system was pulled until the disc for the left atrium was against the septum. Thereafter, the disc for the right atrium was deployed and placed at the right atrium

septum. The position of the ASD closure device was confirmed by transoesophageal and transthoracic echocardiography and fluoroscopy (**Figure 1E, Figure 1F**), and the ASD device was disengaged from its introducer assembly (**Moving image 1**). The intervention was completed successfully, and the further course was uneventful. An echocardiographic study showed no residual shunting (**Moving image 2**). An anticoagulation protocol was followed before and during the intervention as well as postoperatively. In dextrocardia, the interatrial septum is directed anteriorly, malpositioned, and challenging to access compared to normal cardiac ASD. The technical difficulties encountered during device closure of ASD in dextrocardia required skilful interventionists, appropriate planning, and the use of imaging technologies for patient safety and a successful intervention.
