# Accuracy in adversity: double-stitch injury during balloon mitral valvotomy managed with device closure followed by interval balloon mitral valvotomy in an antenatal care patient at 7 months of gestational age

**Figure 1.** Percutaneous closure of double-stitch injury by Muscular VSD device followed by interval BMV. A) Schematic diagram showing the absence of the true atrial septum near the lateral and inferior borders of the LA and the path traversed by the TSP needle from the RA across the pericardial space to the LA<sup>3</sup>. B) Dye injection showing the Mullins sheath (Medtronic) positioned in the LA after TSP. C) Dye injection in the RA showed no flow across the Muscular VSD device, which was sealing the double-stitch injury with one disc in the LA and another disc in the RA. D, E) Muscular VSD device placed at the roof of the LA and RA, with no flow across it in the apical four-chamber view. F) Device across the IAS seen in the PSAX view. G) Muscular VSD device seen in the LA in the PLAX view. H) TOE-guided TSP during interval BMV. I) Accura balloon inflated across the MV. J, K) Post-BMV TTE showing a well-opening mitral valve and the device in the LA. BMV: balloon mitr

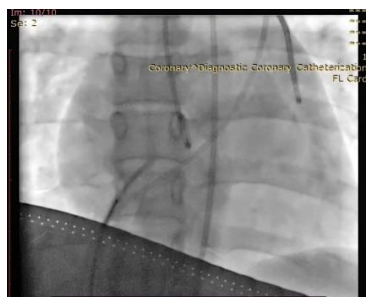
**Brockenbrough-Braunwald needle positioned for TSP as per Standard fluoroscopic landmarks in AP view**

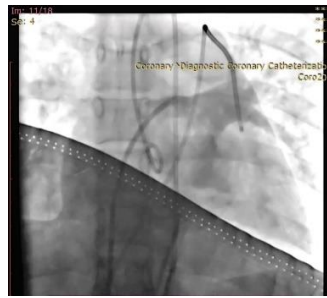
**Dye injection s/o Mullins sheath positioned in LA after TSP**

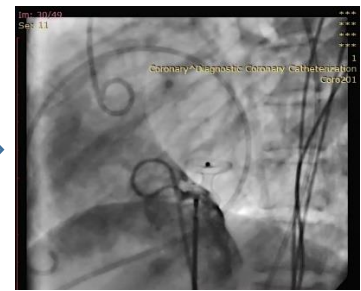
**Dye injection in RA s/o no flow across the Muscular VSD device sealing Double stitch injury with one disc in LA and another disc in RA**

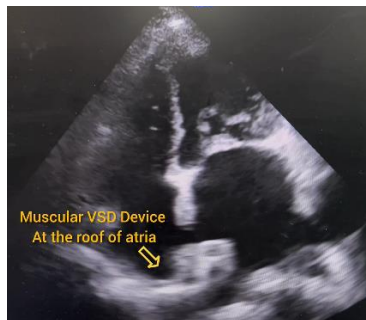
**Apical four chamber view showing Muscular VSD device placed at the roof of LA and RA**

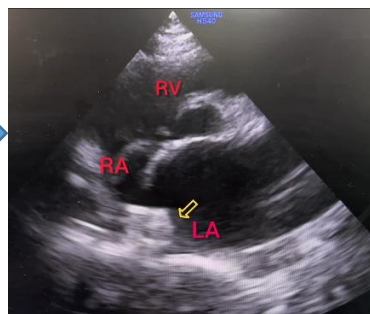
**Device across IAS seen in PSAX View .**

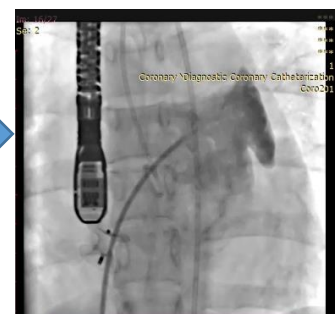
**TEE guided TSP during interval BMV**

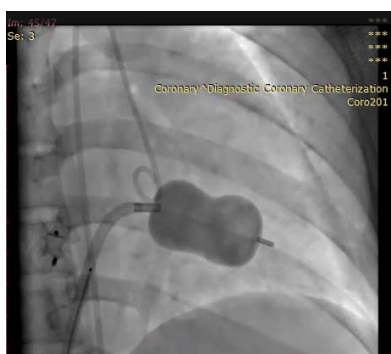
**ACCURA balloon inflated across MV.**

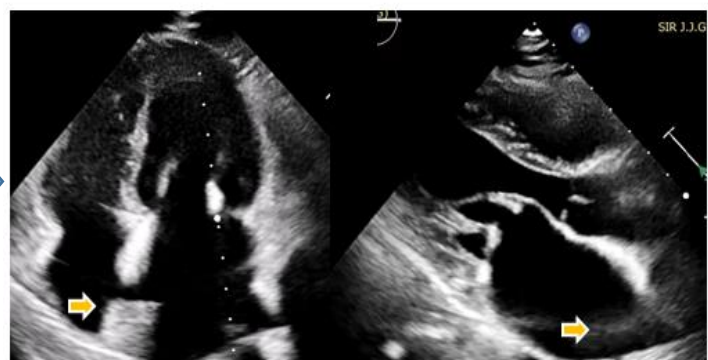
**Supplementary Figure 1. Visual abstract.**

**Post-BMV TTE shows the increased opening of the mitral valve and device in situ.**
